Inspection Report

Property Address:
1112 SampleTr.
Raleigh NC 27600

Innovative Home Inspections

Date: 7/20/2011	Time:	Report ID: 11-0720PM KTS
Property: 1112 SampleTr. Raleigh NC 27600	Customer: Sample Sample	Real Estate Professional:

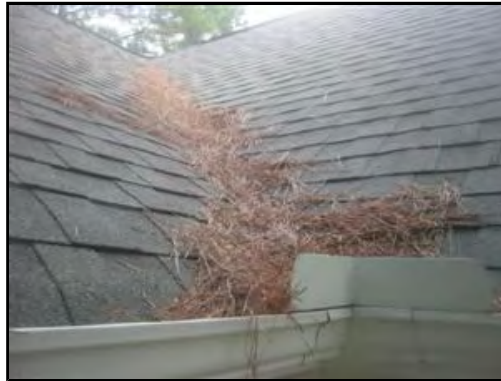
1.0 Picture 1

Debris noted on the front roof at the left valley and in the gutters. Remove debris to prevent uneven wearing of the shingles over time and to allow for proper water flow. Clean off roof and gutters as needed.

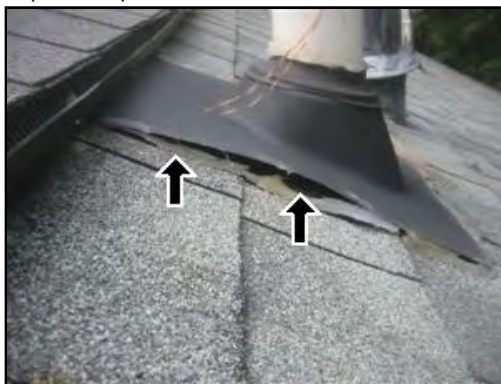
1.2 Picture 1

The boot for the furnace flue is improperly installed. The flashing is lifted and not properly installed under the upper shingles to help divert water. Repair or replace as needed.

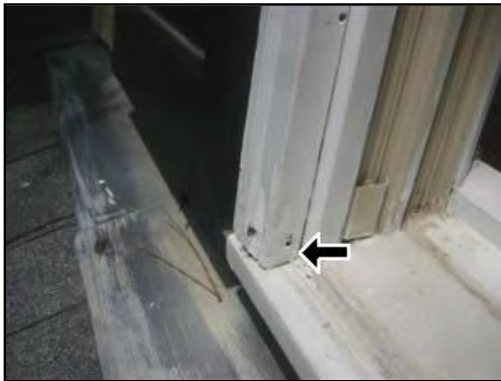
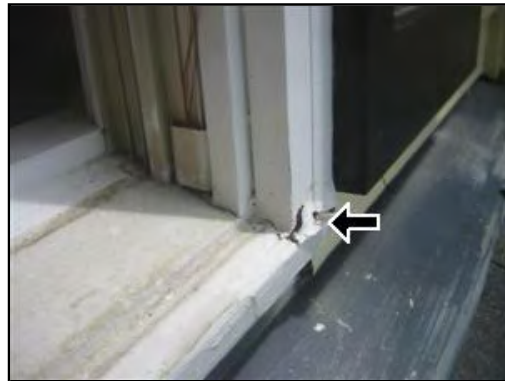
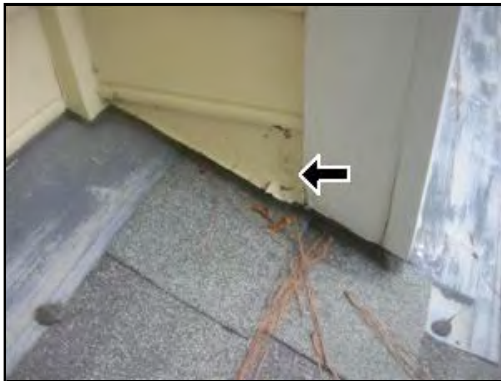
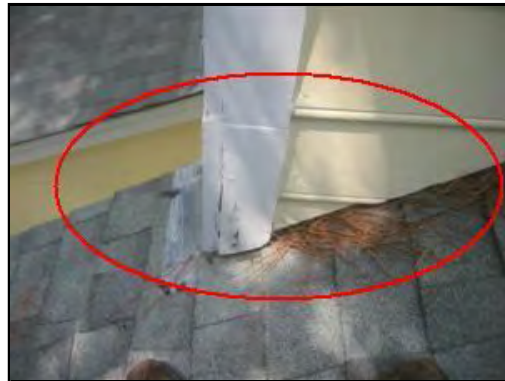
2.0 Picture 1

Wood rot noted in the window trim for the master bathroom window, (Picture 1-2) wood rot in siding to the left of the master bathroom window at corner, (Picture 3) wood rot in siding on the right side of the house, to right of the front porch area at roof line. (Picture 4) Repair or replace as needed.

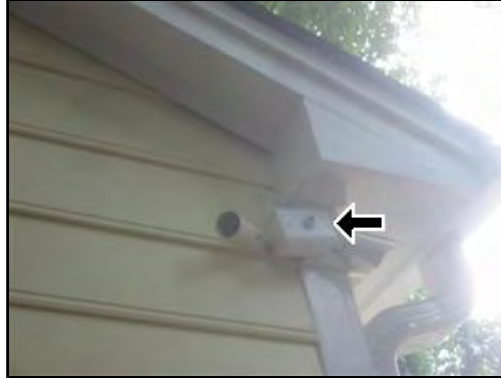
2.7 Picture 1

Improperly installed wiring noted on the left, front corner of garage. The wire is a drop cord style wire that could easily overheat and is a safety concern. Repair or replace as needed by a licensed electrical contractor.

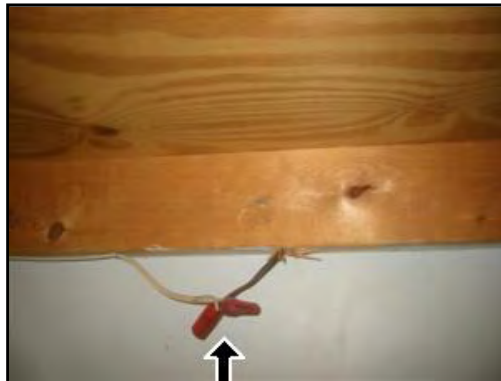
3.6 Picture 1

Improperly spliced wire noted under the work bench on the rear wall of the garage. This appears to be a plug in type cord and should not be used due to safety concerns. Repair or replace as needed.

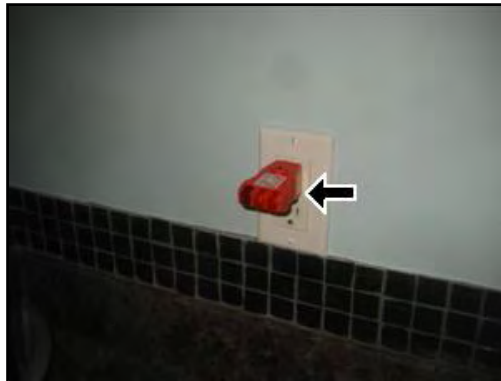
4.8 Picture 1

The GFCI protected outlet to the left of the stove did not perform properly to testing. The outlet continued to have power even when the circuit was tripped. In the event of an electrical short or ground GFCI protected outlets are designed to trip the circuit. This action protects the user from electrical shock injury. Recommend further evaluation by a electrical contractor and repair or replace as needed.

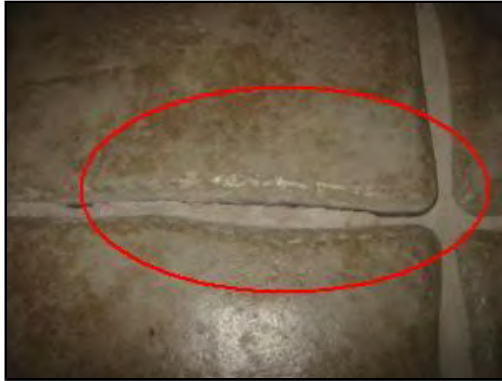
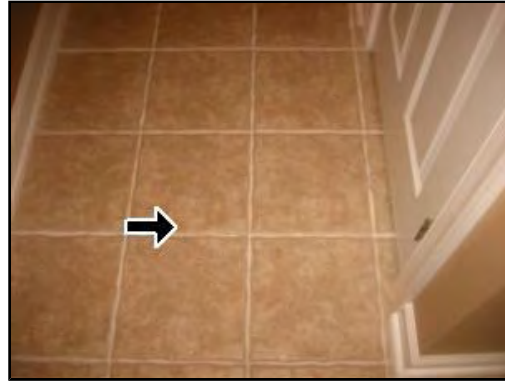
5.2.D Picture 1

Loose tile and grout noted in front of the closet door in the downstairs hallway area. Repair or replace as needed to prevent tile from cracking over time.

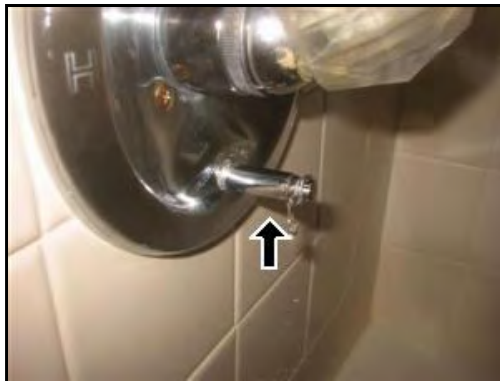
6.7.C Picture 1

The shower stem diverter leaks when the shower is in use. Repair or replace as needed.

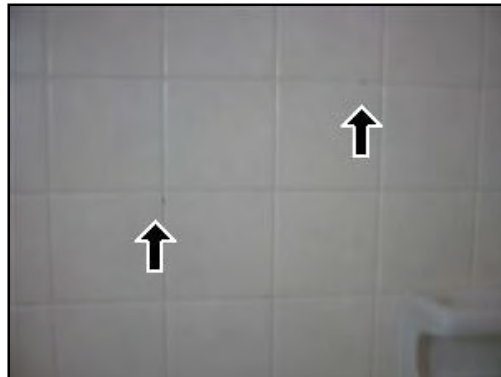
6.11.C Picture 1

Several areas of the tub/shower tile have missing grout. Replace grout as needed to prevent water penetration.

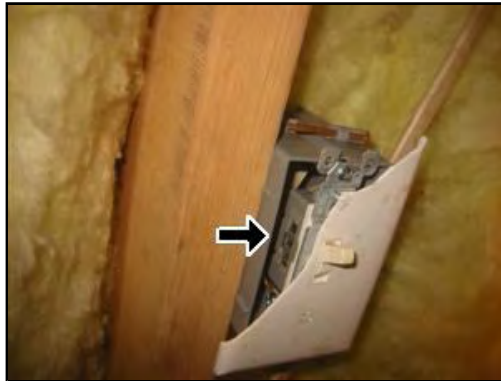
7.10 Picture 1

Damaged light switch cover noted just inside the crawlspace door. Repair or replace as needed.

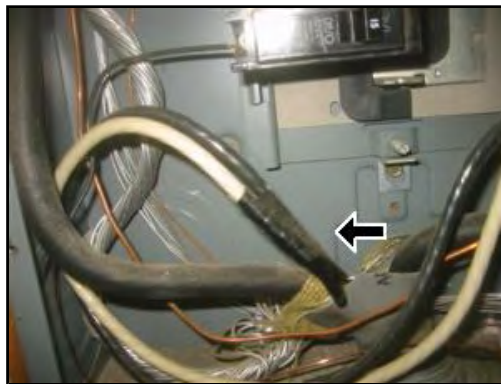
9.1 Picture 1

(2) Improperly terminated wire noted in the rear, sub-panel located at the HVAC units. Wires should terminate with a wire nut or removed if abandoned. Repair or replace as needed.

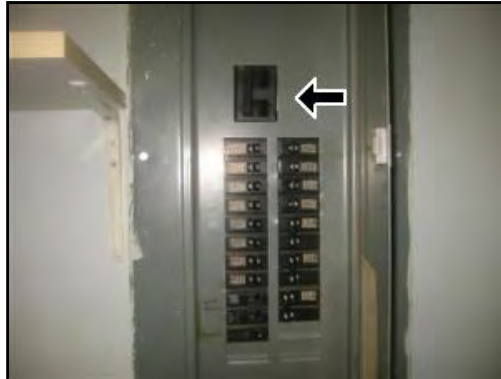
9.6 Picture 1

Main electrical panel is located on the left wall of the garage. (Picture 1) The top circuit breaker is the main disconnect for the house.

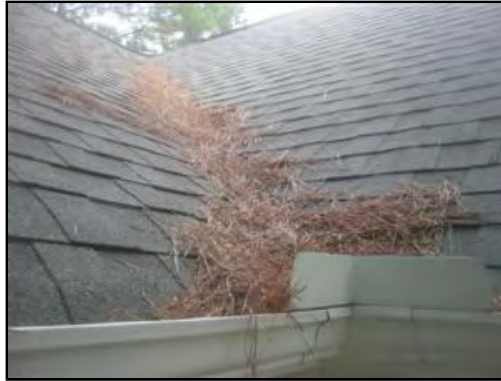
1.0 Picture 1

Debris noted on the front roof at the left valley and in the gutters. Remove debris to prevent uneven wearing of the shingles over time and too allow for proper water flow. Clean off roof and gutters as needed.

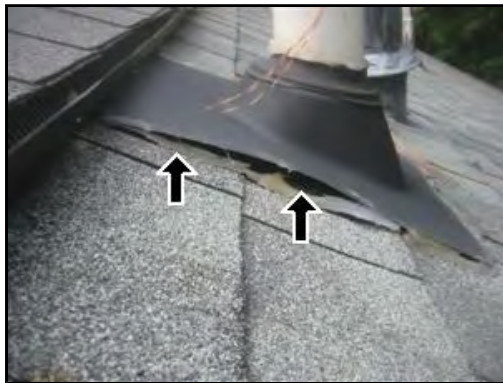
1.2 Picture 1

The boot for the furnace flue is improperly installed. The flashing is lifted and not properly installed under the upper shingles to help divert water. Repair or replace as needed.

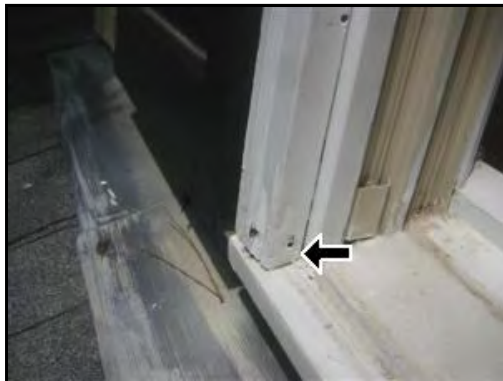
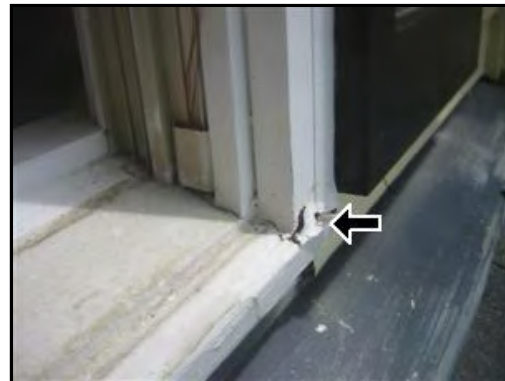
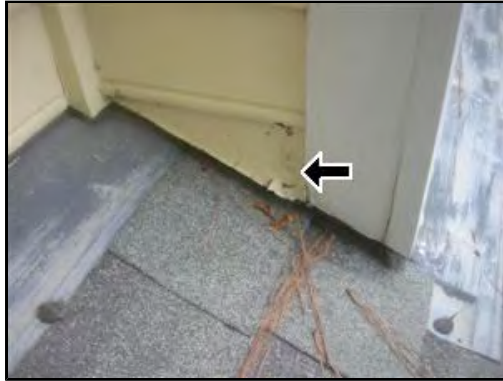
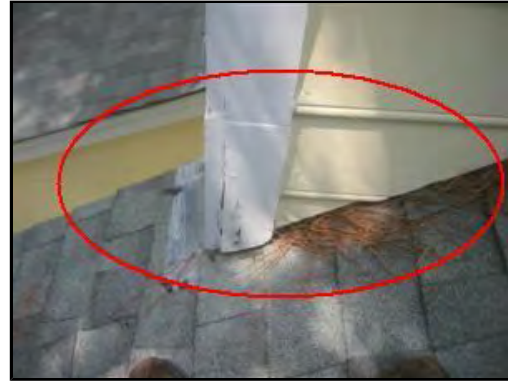
2.0 Picture 1

Wood rot noted in the window trim for the master bathroom window, (Picture 1-2) wood rot in siding to the left of the master bathroom window at corner, (Picture 3) wood rot in siding on the right side of the house, to right of the front porch area at roof line. (Picture 4) Repair or replace as needed.

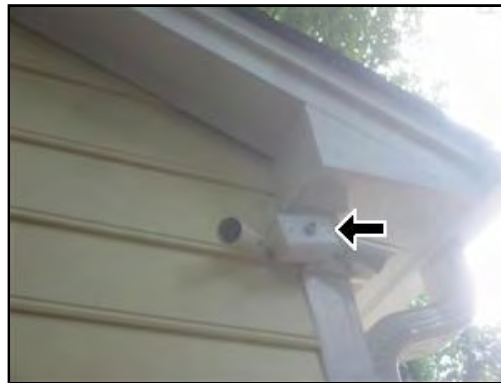
2.7 Picture 1

Improperly installed wiring noted on the left, front corner of garage. The wire is a drop cord style wire that could easily overheat and is a safety concern. Repair or replace as needed by a licensed electrical contractor.

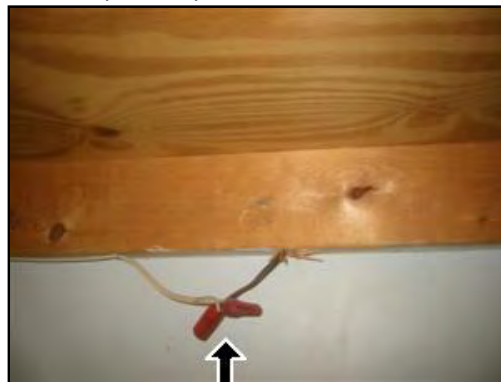
3.6 Picture 1

Improperly spliced wire noted under the work bench on the rear wall of the garage. This appears to be a plug in type cord and should not be used due to safety concerns. Repair or replace as needed.

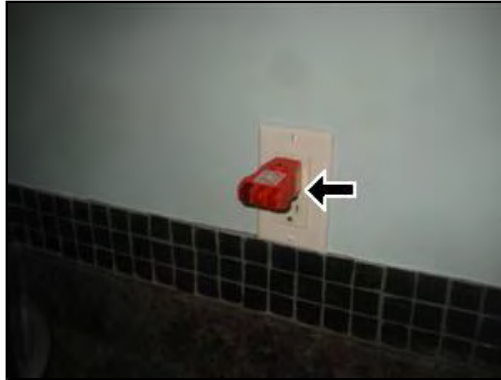
4.8 Picture 1

The GFCI protected outlet to the left of the stove did not perform properly to testing. The outlet continued to have power even when the circuit was tripped. In the event of an electrical short or ground GFCI protected outlets are designed to trip the circuit. This action protects the user from electrical shock injury. Recommend further evaluation by an electrical contractor and repair or replace as needed.

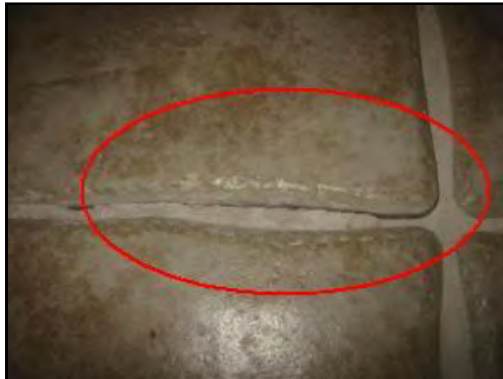
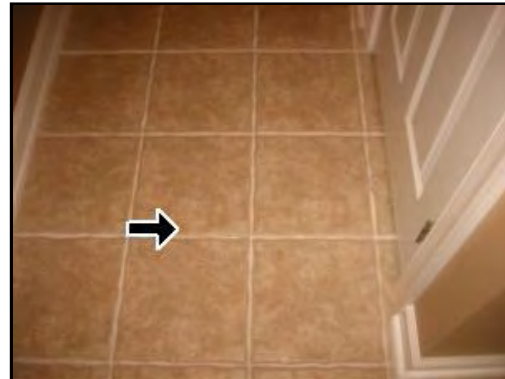
5.2.D Picture 1

Loose tile and grout noted in front of the closet door in the downstairs hallway area. Repair or replace as needed to prevent tile from cracking over time.

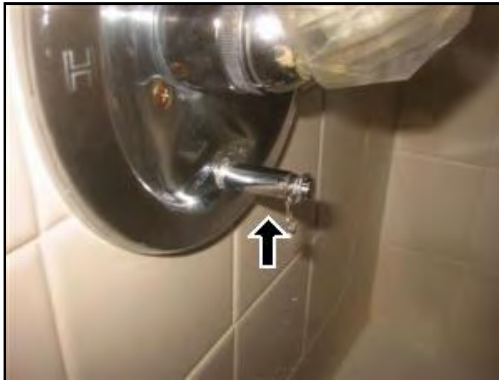
6.7.C Picture 1

The shower stem diverter leaks when the shower is in use. Repair or replace as needed.

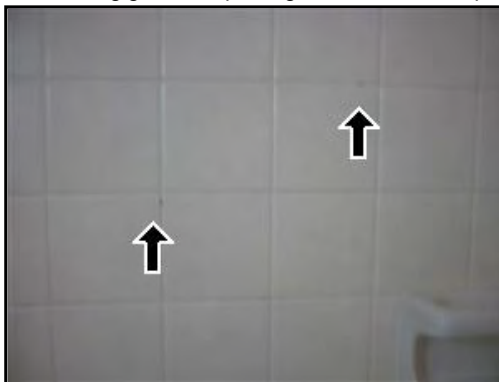
6.11.C Picture 1

Several areas of the tub/shower tile have missing grout. Replace grout as needed to prevent water penetration.

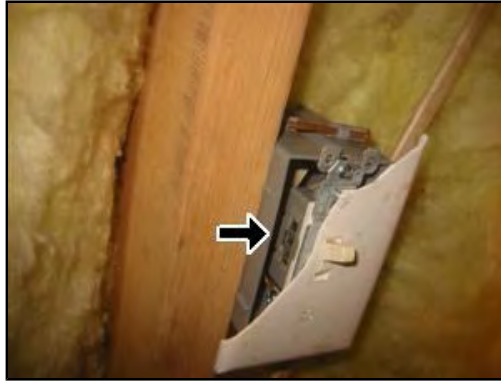
7.10 Picture 1

Damaged light switch cover noted just inside the crawlspace door. Repair or replace as needed.

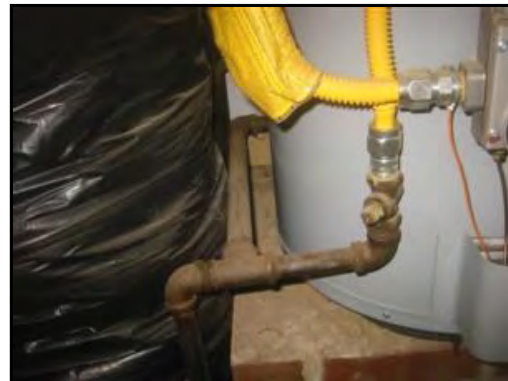
8.3 Picture 1

The flue for the hot water heater is not properly installed and secured. (Picture 1) Also there is no drip leg noted for the gas line to the hot water heater. A drip leg is installed to prevent moisture and debris in the gas line from entering the unit. (Picture 2) Repair or replace as needed.

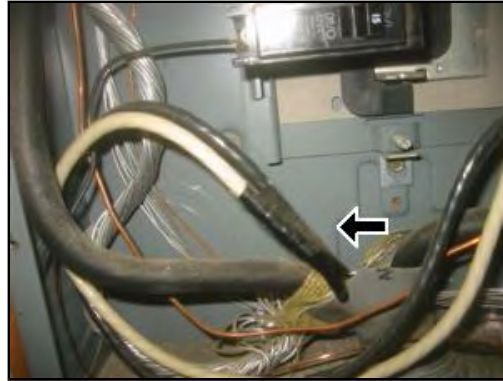
9.1 Picture 1

(2) Improperly terminated wire noted in the main electrical panel. Wires should terminate with a wire nut or removed if abandoned. Repair or replace as needed.
